SNAP-8 MATERIALS REPORT FOR JANUARY - JUNE 1966

NATIONAL AERONAUTICS AND SPACE ADMINISTRATION
LEWIS RESEARCH CENTER

CONTRACT NAS 5-417

VON KARMAN CENTER
AEROJET-GENERAL CORPORATION
AZUSA, CALIFORNIA

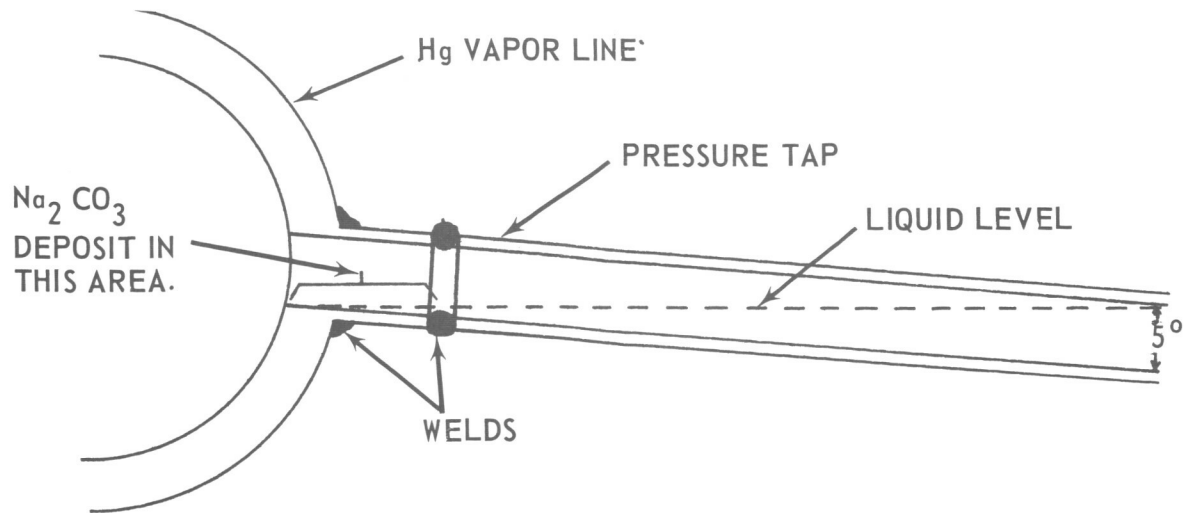
A. SCHEMATIC OF PRESSURE TAP INSTALLATION CONFIGURATION

Typical Appearance of ID of Pressure Tap from
Hg Vapor Line of PCS-1 Phase IV After Step 2 Operation

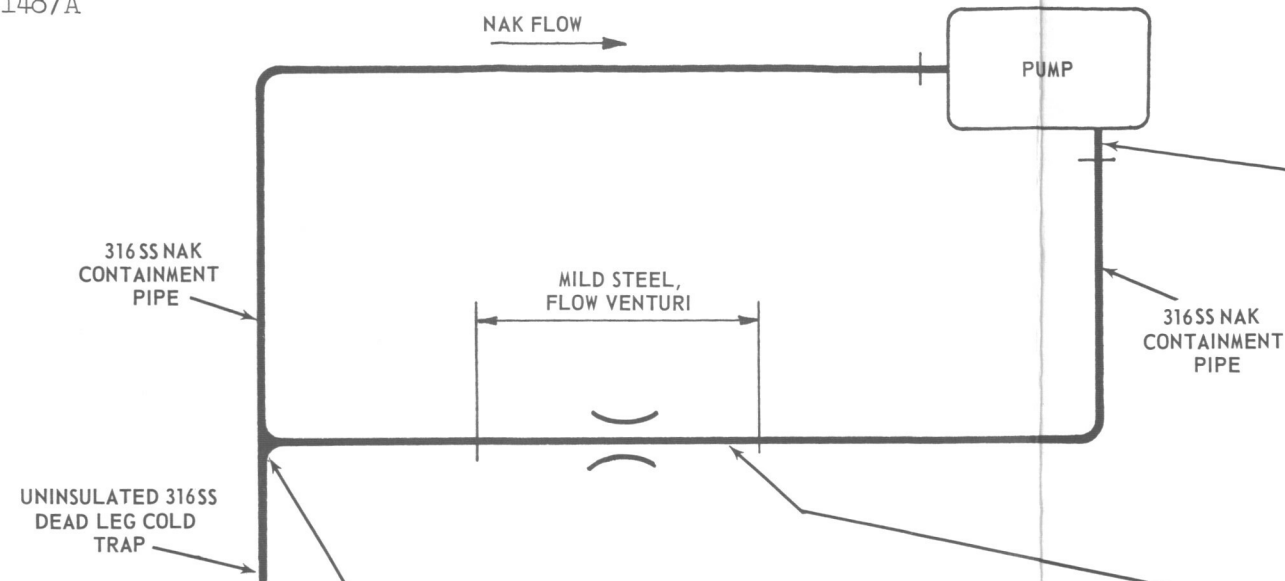
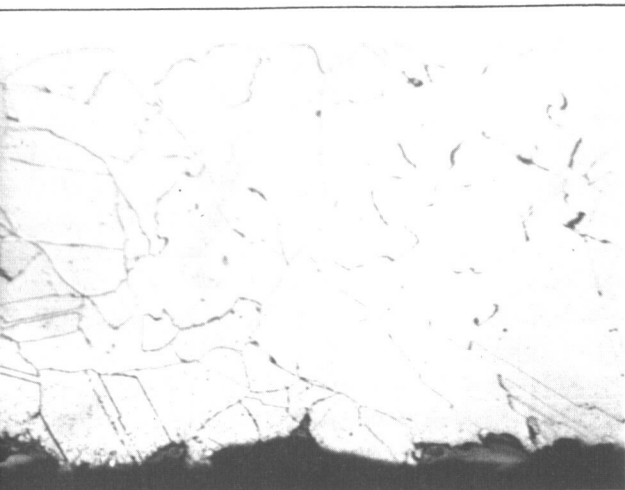
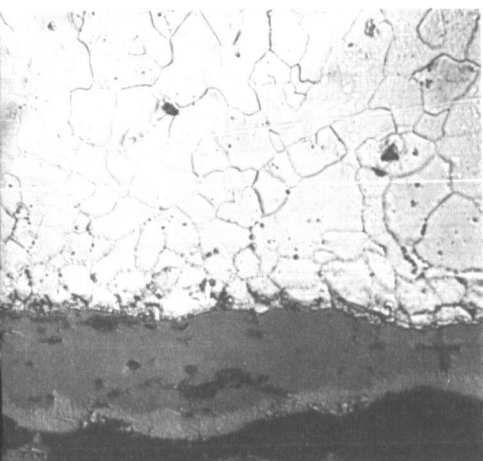
Figure 2 -1

No metallic mass-transfer deposits were detected by visual or metallographic examination of the inside pipe surfaces of any samples. The outside pipe surfaces appeared oxidized as a result of air exposure during high-temperature loop operation. Metallographic examination and micro-hardness determinations revealed, however, that carbon migration, on the NaK side, from the mild steel portion of the system at the flow venturi to the 316 SS NaK containment pipe had occurred. Decarburization depth as determined by microhardness measurements (Figure 3) in the mild steel was approximately 0.020 in., carburization depth in the hot end of the 316 SS cold finger was approximately 0.010 in. Only minor hardening occurred in the 304 SS at the pump discharge and the 316 SS at the venturi inlet. It appeared that most of the effect of the transported carbon occurred in the stainless steel downstream of the venturi and upstream of the pump discharge. It is expected that, with continued loop operation under the same conditions and with the same materials, carbon migration would continue but at a reduced rate because the carbon must diffuse a greater distance to the surface of the mild steel before it can be transported by the NaK. It is also expected that a loss in ductility and impact strength of the stainless steel will occur as a result of the surface carburization, but that it should not deleteriously affect loop operation.

L-9474 INSIDE SURFACE CARBURIZATION

Microstructure of Specimens Removed from LNL-3 After 3130 hours of Isothermal System Operation at Between 1125 and 1175°F

OUTSIDE SURFACE OXIDATION

← SURFACE
OXIDE

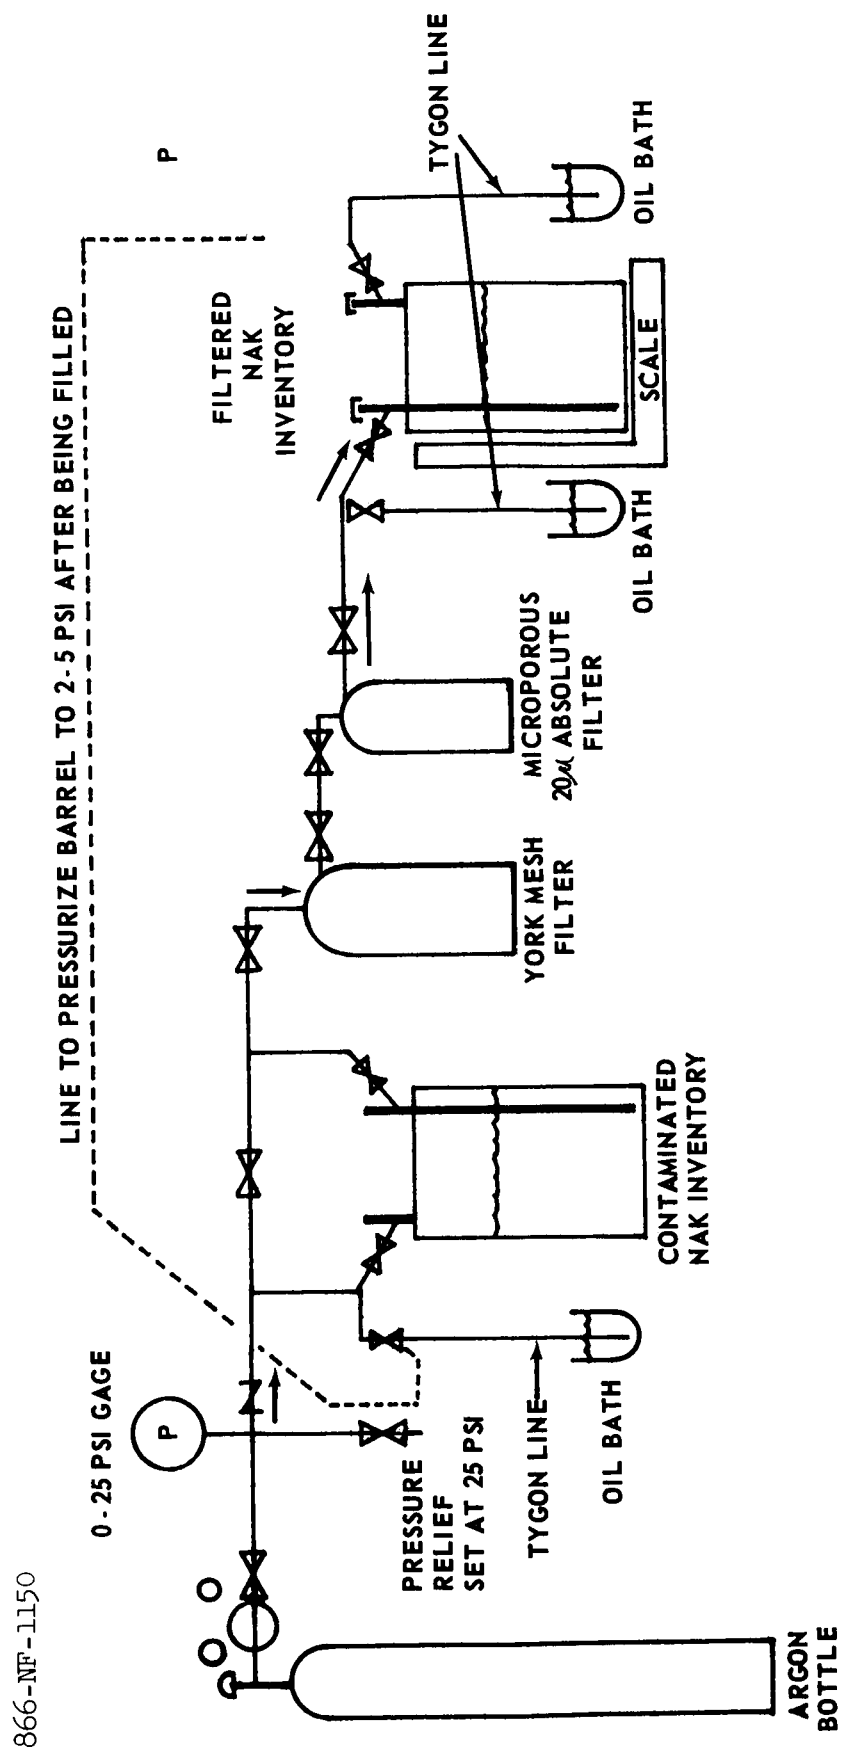
Figure 4

A filtration system utilizing 2 filters in series was used (Figure 4). The contaminated NaK container is pressurized to push the contaminated NaK through a large filter containing York stainless-steel mesh. This acts as a depth filter and removes the greatest portion of the contamination. The NaK then passes through a 20 micron (absolute) bed filter to remove particles that may have passed through the depth filter.

Schematic of System for NaK Purification by Filtration

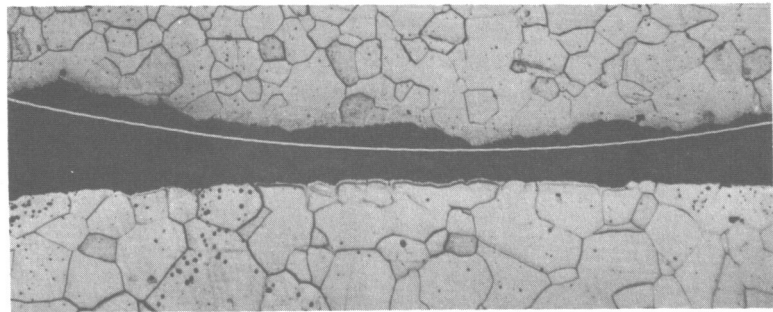
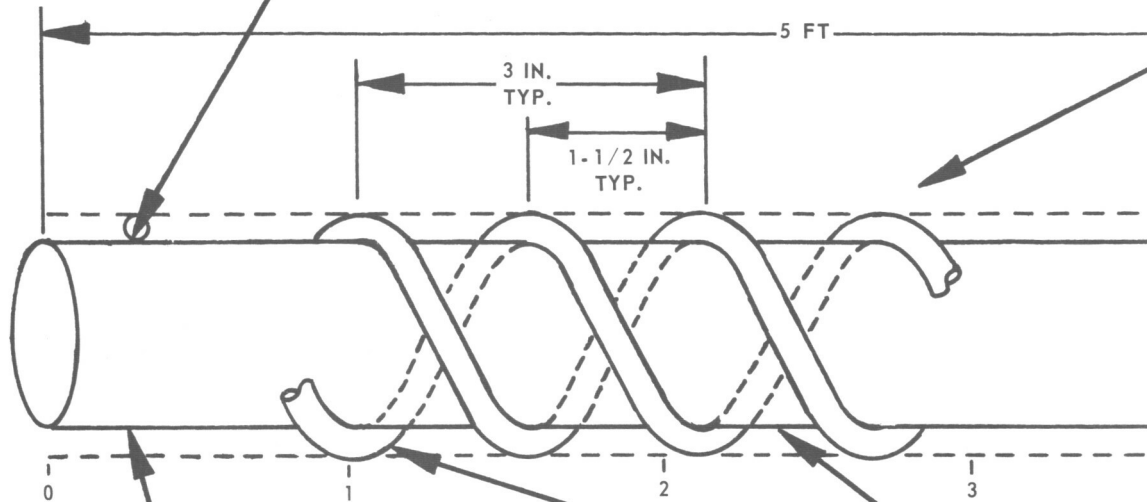
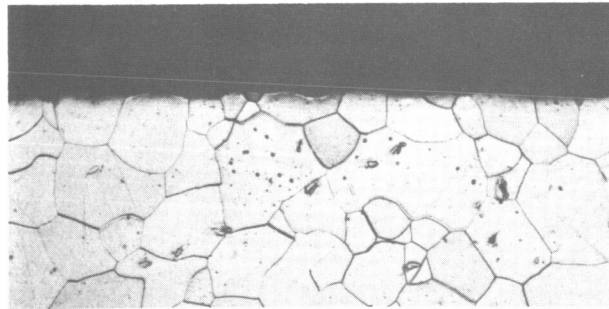
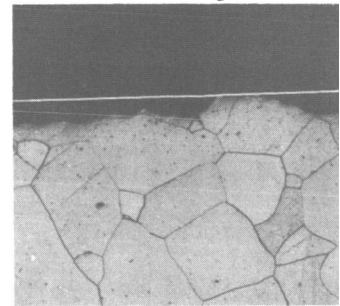
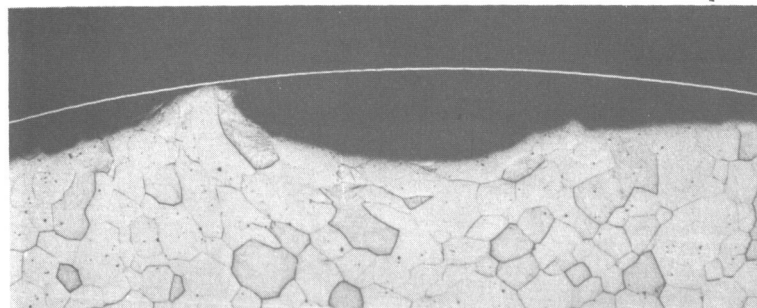
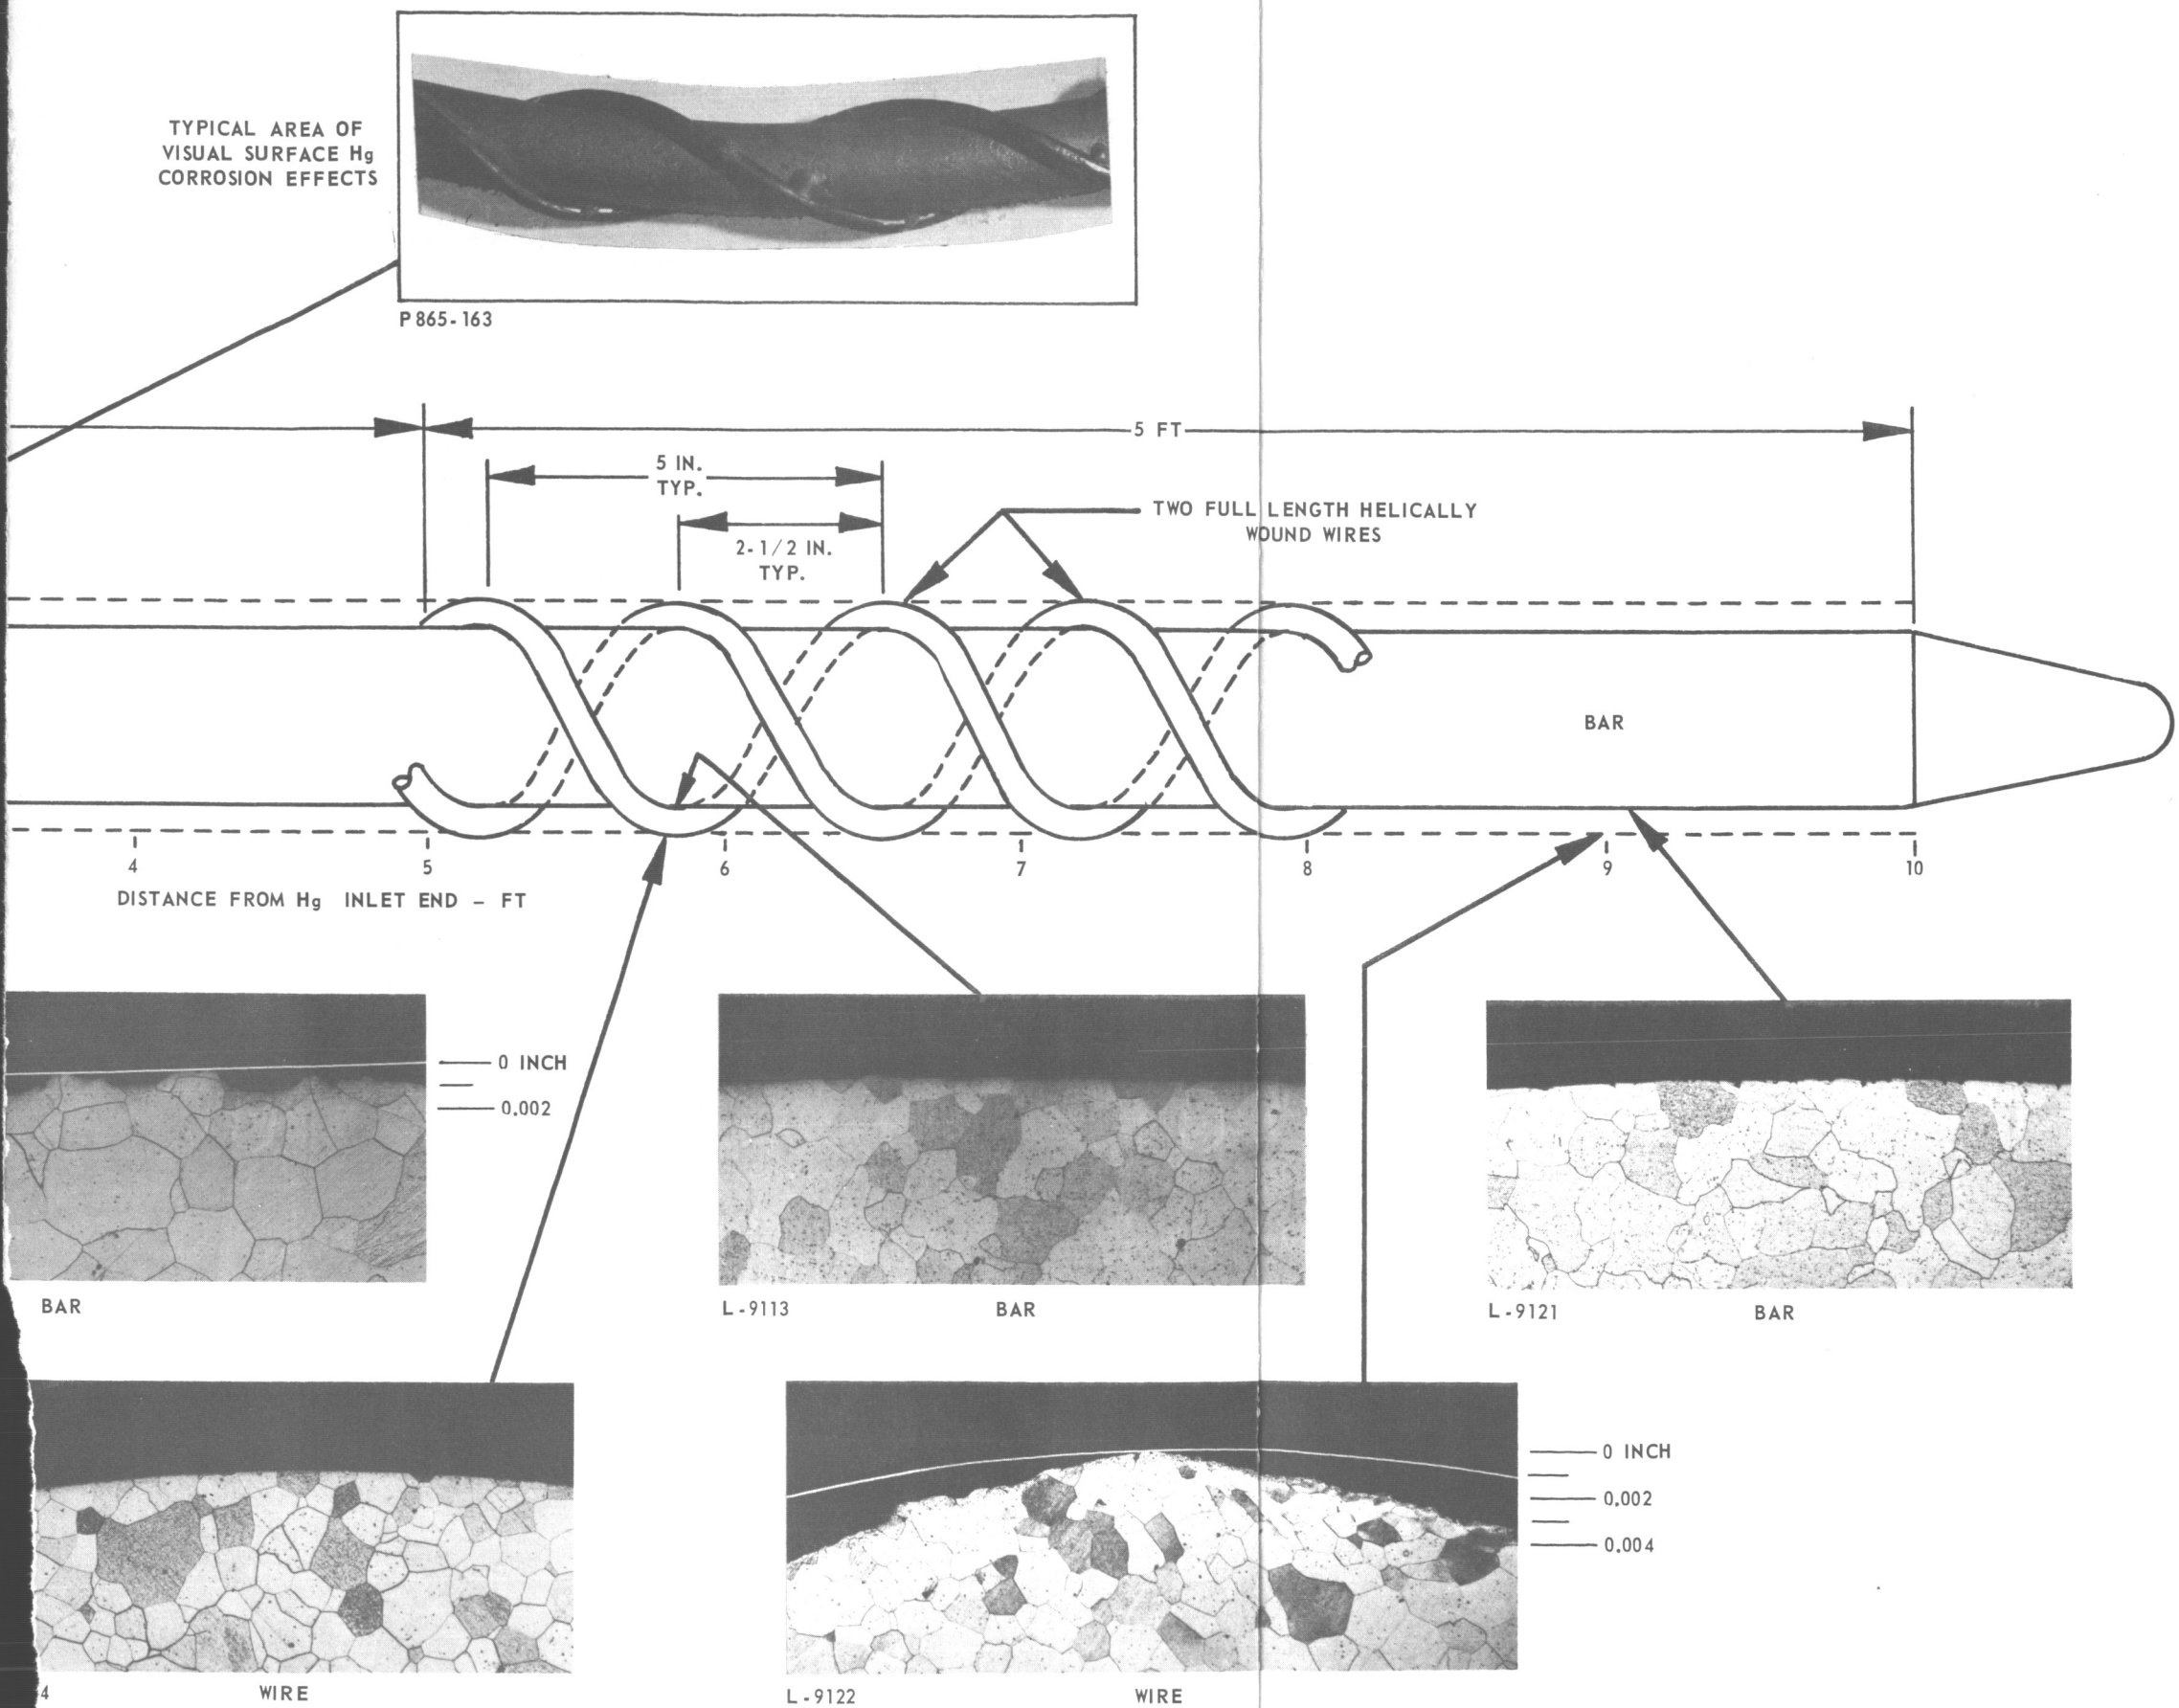
WIRE-BAR (AT BOTTOM) INTERFACE

INDICATED WHITE LINE REPRESENTS PRESUMED ORIGINAL WIRE SURFACE. ETCHANT: VILLELA'S

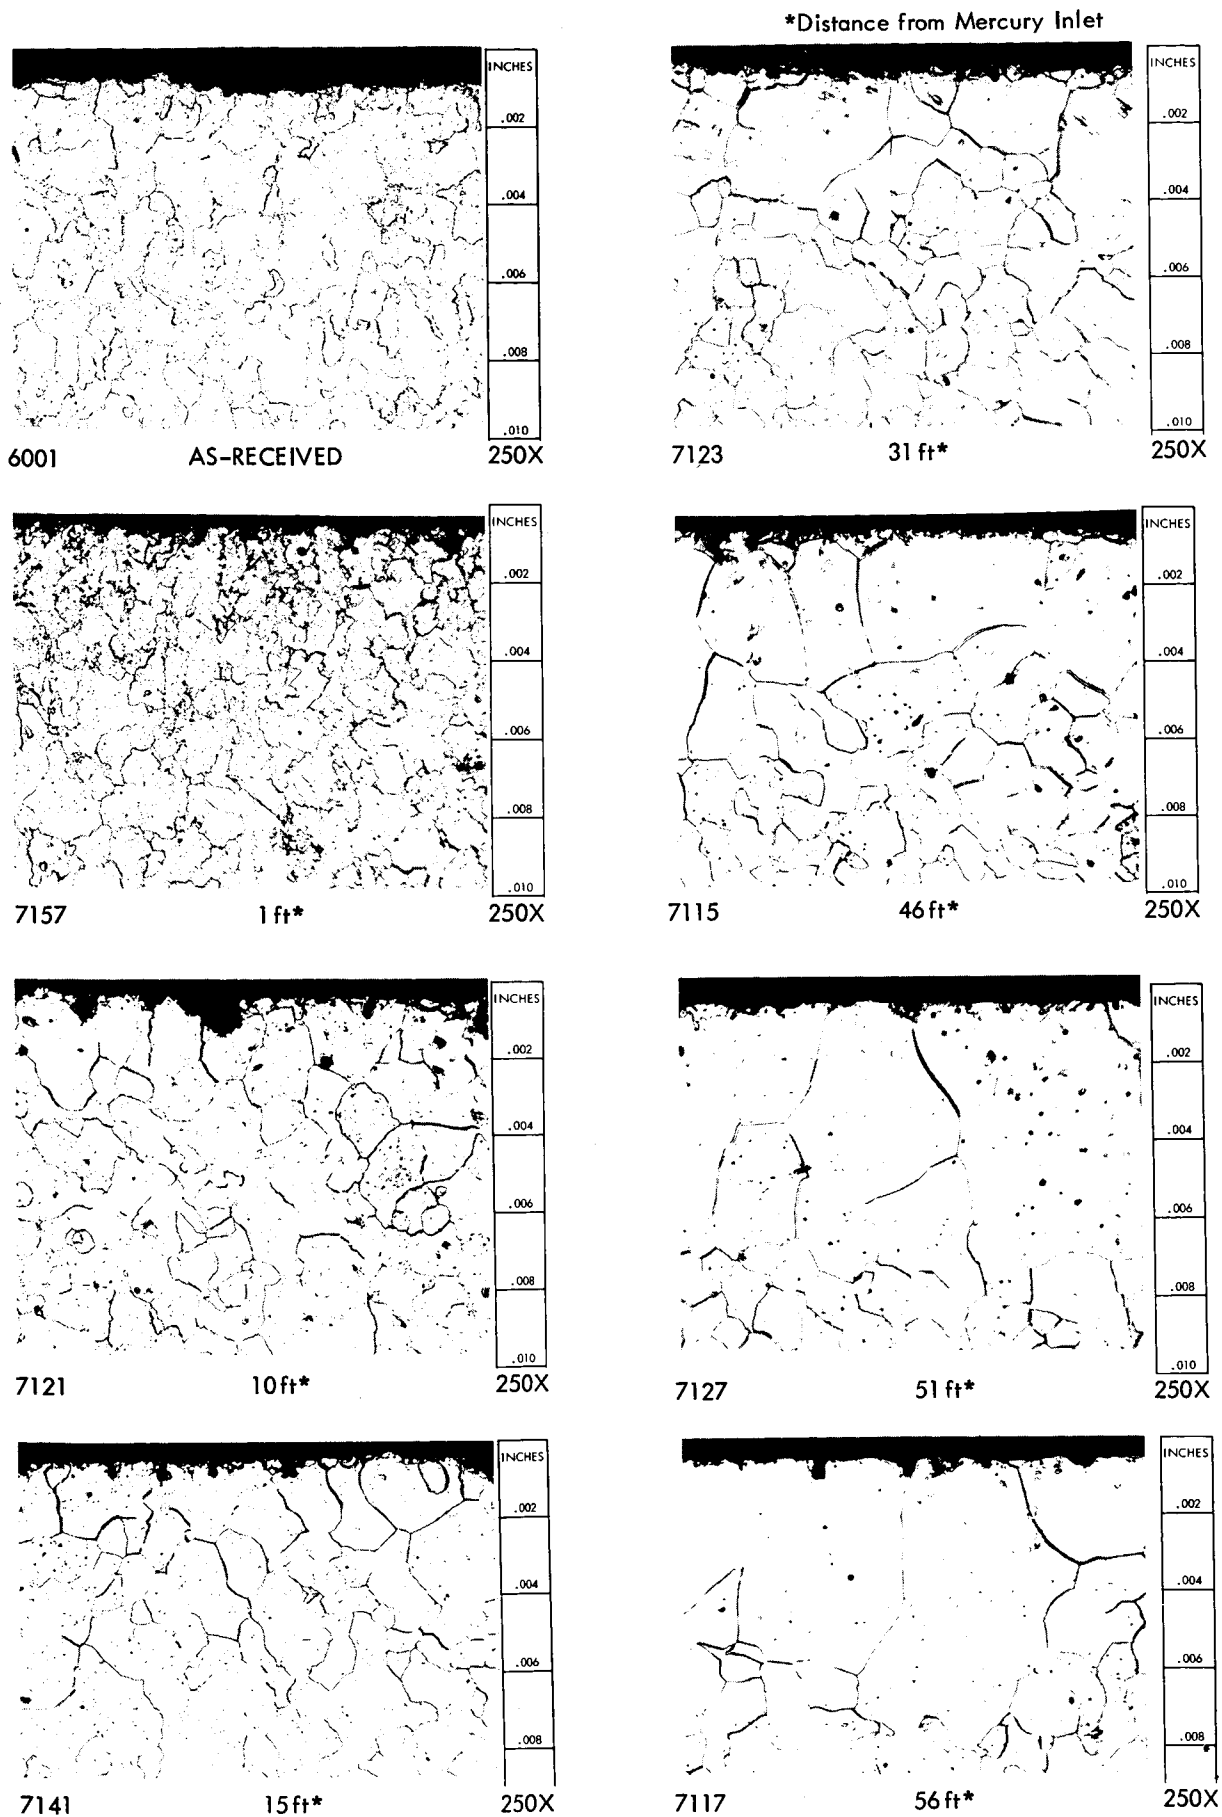
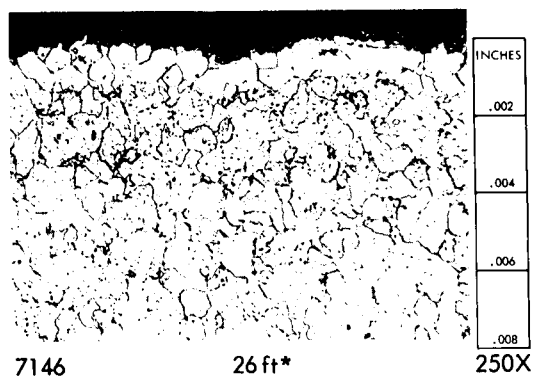
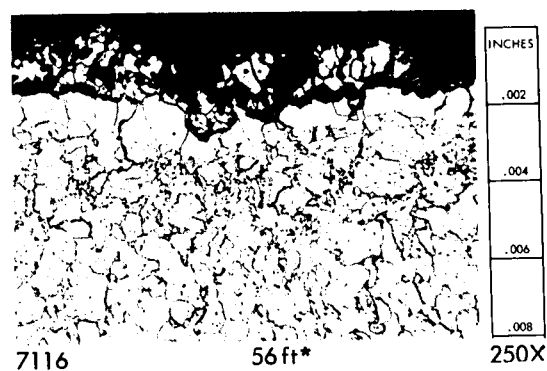
Figure 16

Corrosion product deposition (Figure 16) was found immediately after the boiler inlet plug region (5 to 12 ft from the mercury inlet) with a maximum thickness of 0.004 in. There were minor deposits at the end of the boiler (50 ft from the mercury inlet) that were approximately 0.001 in. thick.

MICROSTRUCTURE OF THE NaK SIDE OF THE 9Cr-1Mo TUBING - CL 4 BOILER

MICROSTRUCTURE OF THE MERCURY SIDE OF THE 9Cr-1Mo
TUBING - CL 4 BOILER COILED SECTION

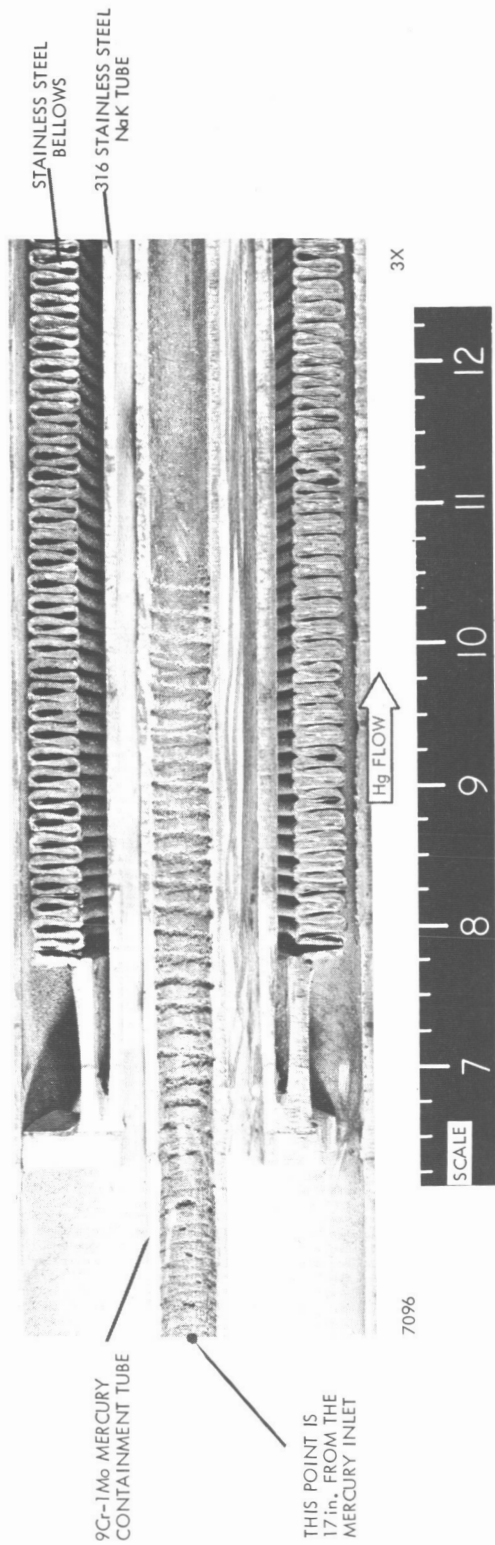
Figure 17

In the CL-4 boiler, the area of major pitting was 17 to 26 in. from the mercury inlet or in the preheat section of the boiler (Figure 17). In this area a large percentage of the pits had united to form transverse grooves (0.0265 in. deep max) and shallower grooves at 20° from the transverse position. The groove configuration indicates the effect of the tight pitch region of the various multipitch plugs operated in this boiler. The probability that some form of tube wall corrosion would appear in this area was high since corrosion was noted in the tight-pitch region of the multipitch plugs when they were removed after the boiler performance tests.

PHOTO MICROGRAPH - CL 4 BOILER INLET SECTION
